# Mare Island Infrastructure Assessment (MIIA) Project

## **Project Overview and Highlights**

Presented by Anne Girtz, PE  
West Yost Senior Engineer, Asset Management

North Bay Watershed Association  
October 4, 2024 Board Meeting

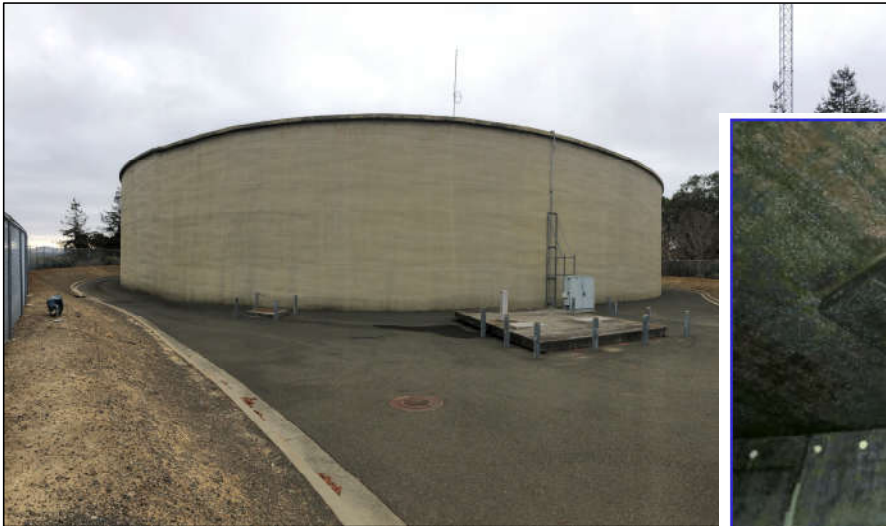
- Exterior of the tank in good condition with isolated areas of moderate surface damage
- Interior concrete and structural components in good condition; interior piping has minor to moderate corrosion on fittings
- Seismic: maximum allowable water level in the tank should be limited to 7 feet below the roof soffit to maintain structural integrity during and after a seismic event

Concrete water tank (constructed 1999) located at the top of Club Dr. near USDA Forest Service building

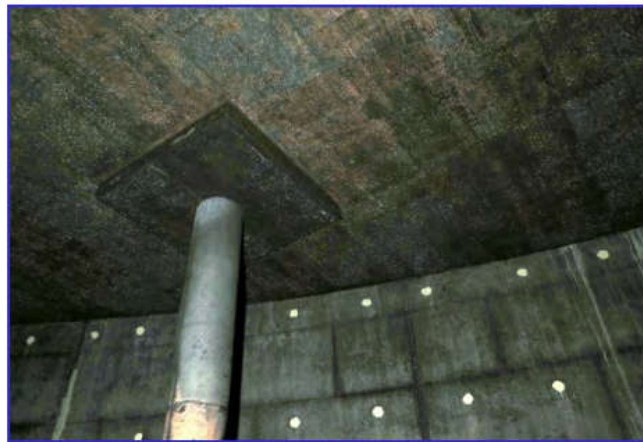
Concrete support column (interior of tank)

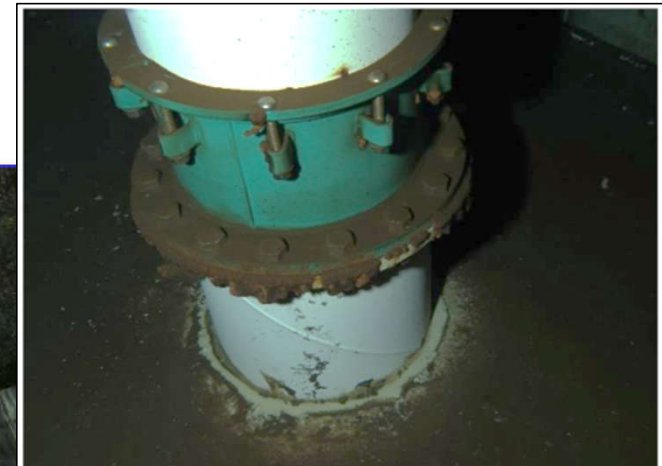
Minor galvanic corrosion on inlet pipe flange (interior of tank)

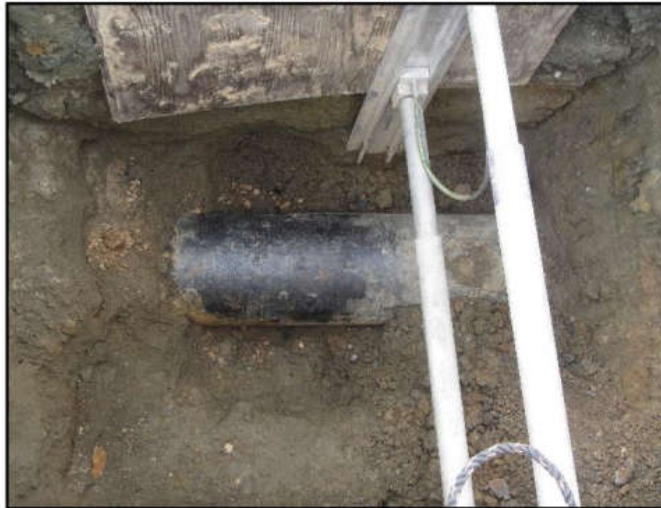
### **Example 1: 20-inch cast iron pipe in Azuar Ave east of Building 1296**

- 1931 pipe Class standard
- Minor surface corrosion; good exterior condition otherwise
- 18% wall thickness loss; moderate interior corrosion

Looking down at pipe, facing southwest

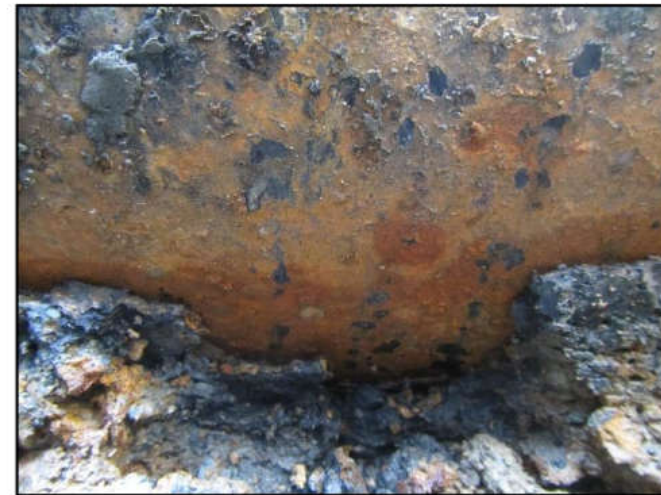
Side of pipe with minor surface corrosion

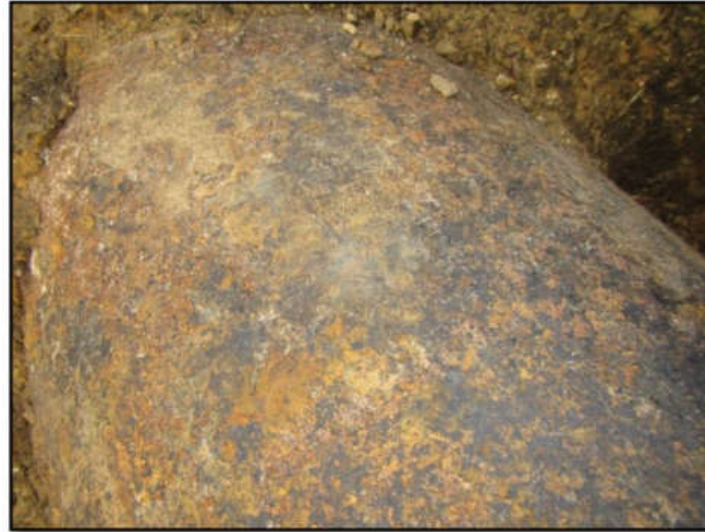
- 1908 pipe Class standard
- Minor surface corrosion; good exterior condition otherwise
- 22% wall thickness loss; significant interior corrosion

*Photo 3-27. Minor surface corrosion.*

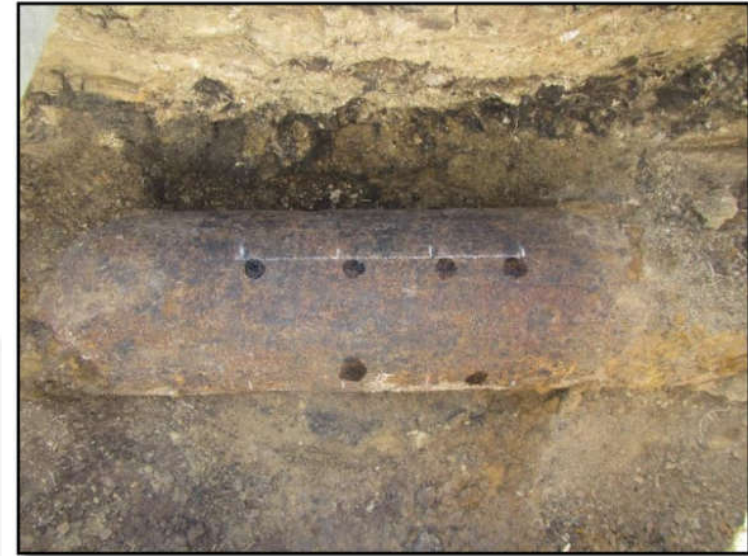
**Example 2: 12-inch cast iron pipe on the east side of Walnut Ave, between Building 521 and parking stalls**

*Photo 3-26. 12-inch cast iron pipe.*

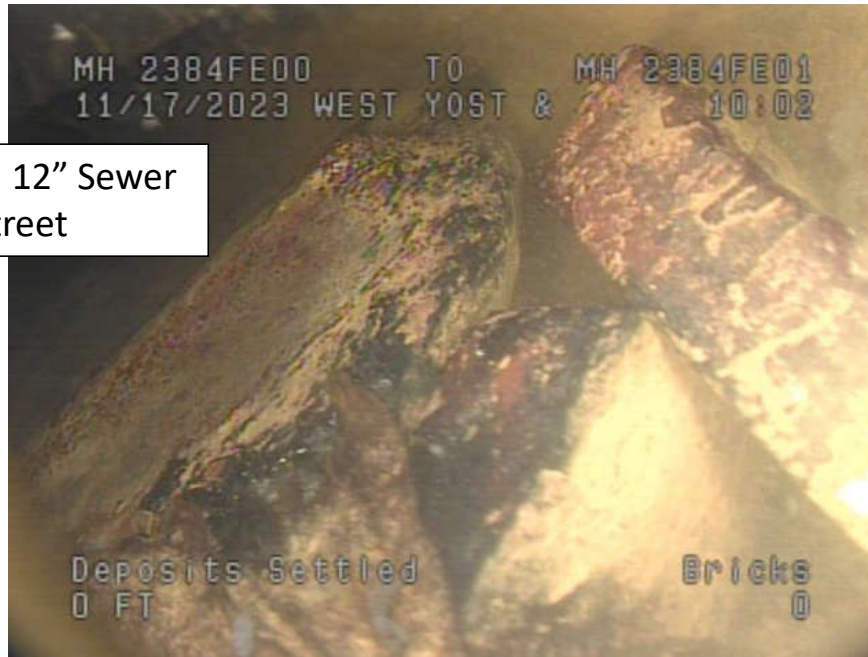
Bricks in 12" Sewer  
– 15<sup>th</sup> Street

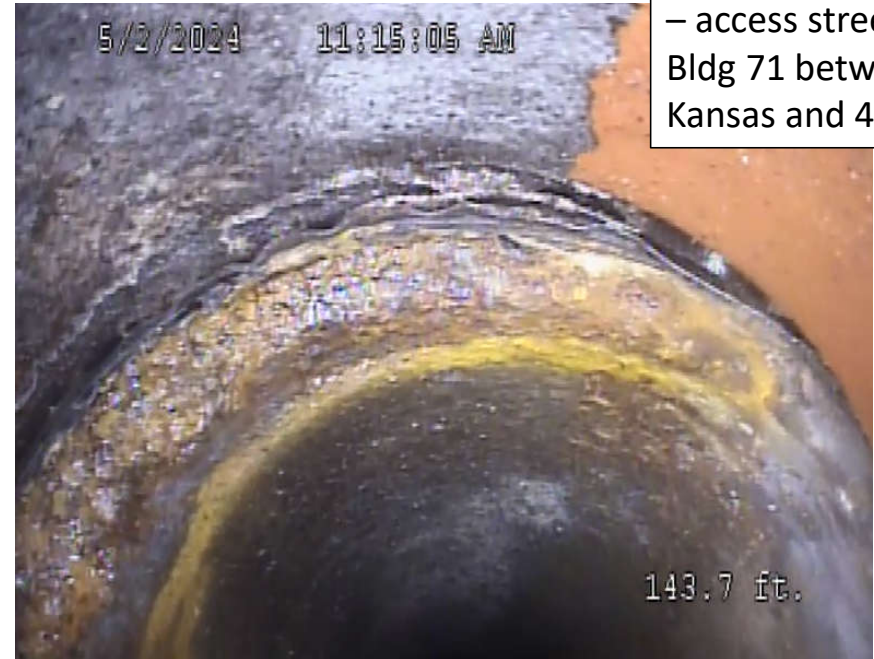
Large offset in 8"  
– access street  
Bldg 71 between  
Kansas and 4<sup>th</sup> St

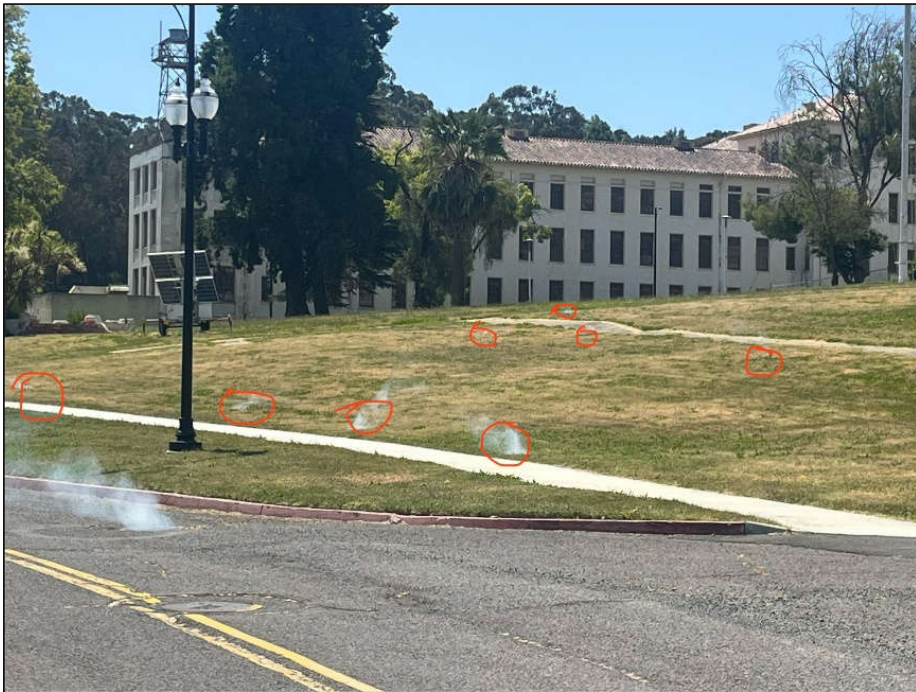
Smoke appearance at locations near Touro University
