# Golden Mussel

*Limnoperna fortunei*

**Presented by: Drew Gantner  
Solano County Water Agency**

**For: North Bay Watershed Association**

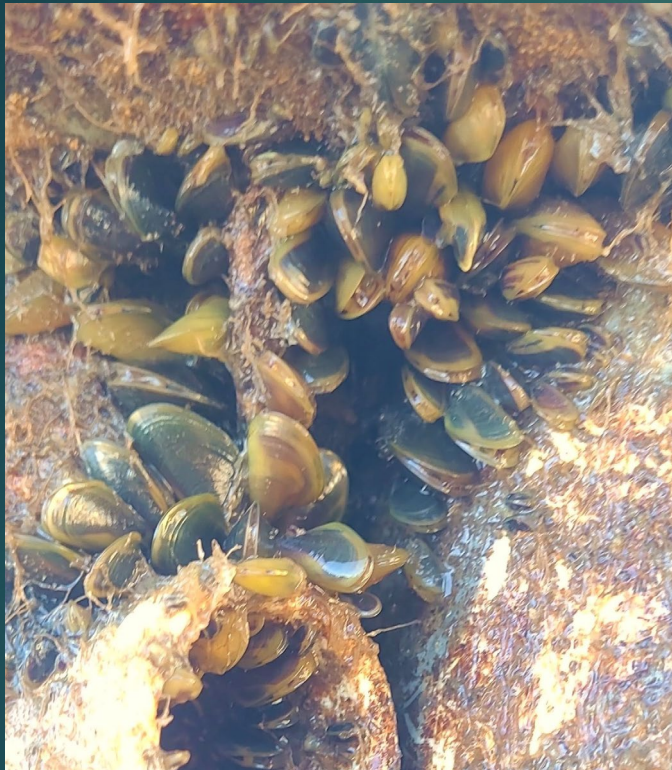
Golden Mussels colonizing water quality monitoring equipment in the Sacramento Delta (DWR).

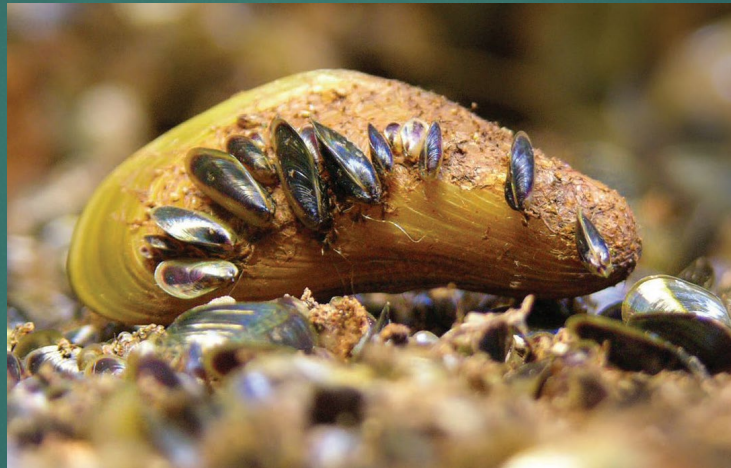
Juvenile Golden Mussels growing on an adult golden mussel (Mountinho, 2021).

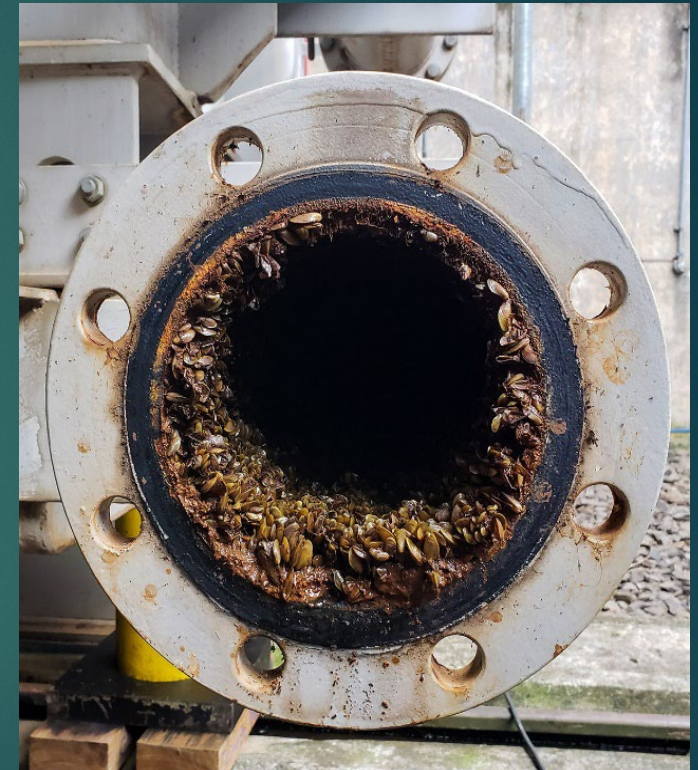
Golden mussels colonizing a water pipe at a hydroelectric plant in Brazil (Mountinho, 2021).
